## **Appendix E**

### **Photograph Log**

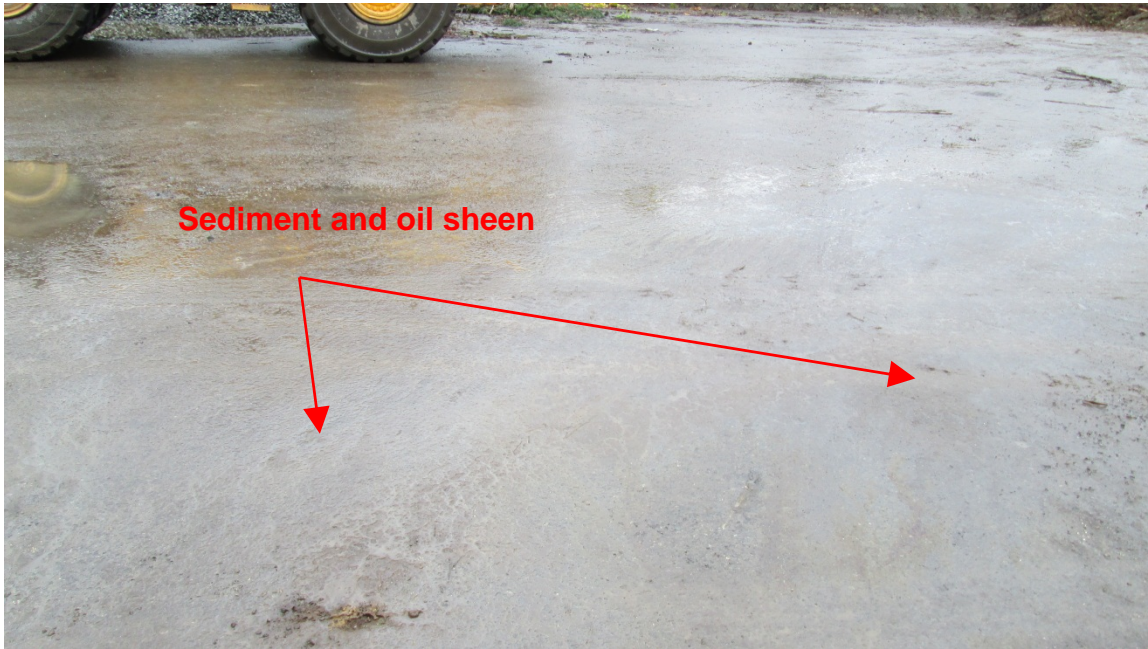
**Photograph 1.** Cathcart Way Operations Center – View of sediment and oil sheen on the asphalt in the southwest portion of the materials storage yard.

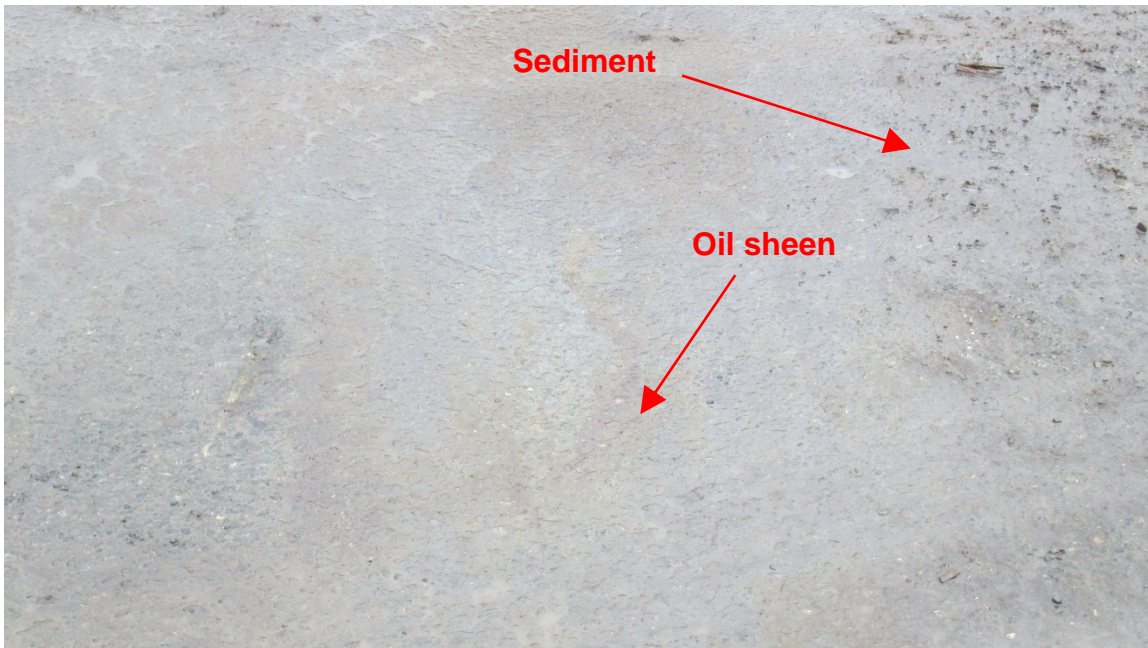
**Photograph 2.** Cathcart Way Operations Center – Close up view of oil sheen and sediment on asphalt shown in Photograph 1.

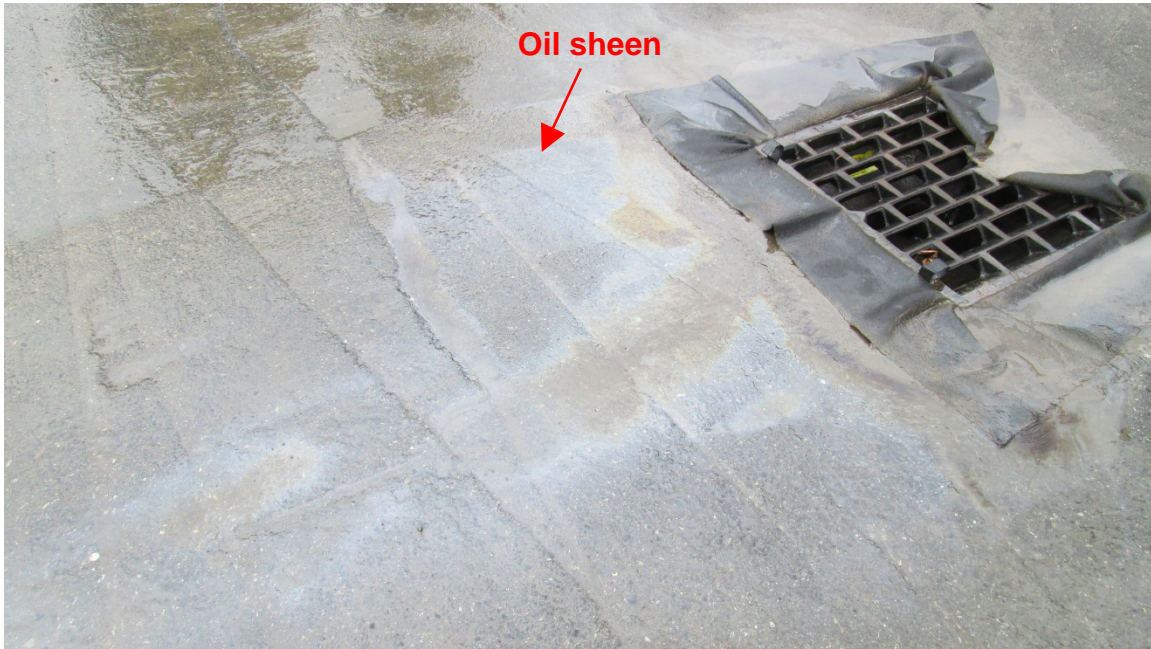
**Photograph 3.** Cathcart Way Operations Center – View of oily sheen and sediment transported to storm drain inlet equipped with inlet protection BMP in the central area of the materials storage yard.

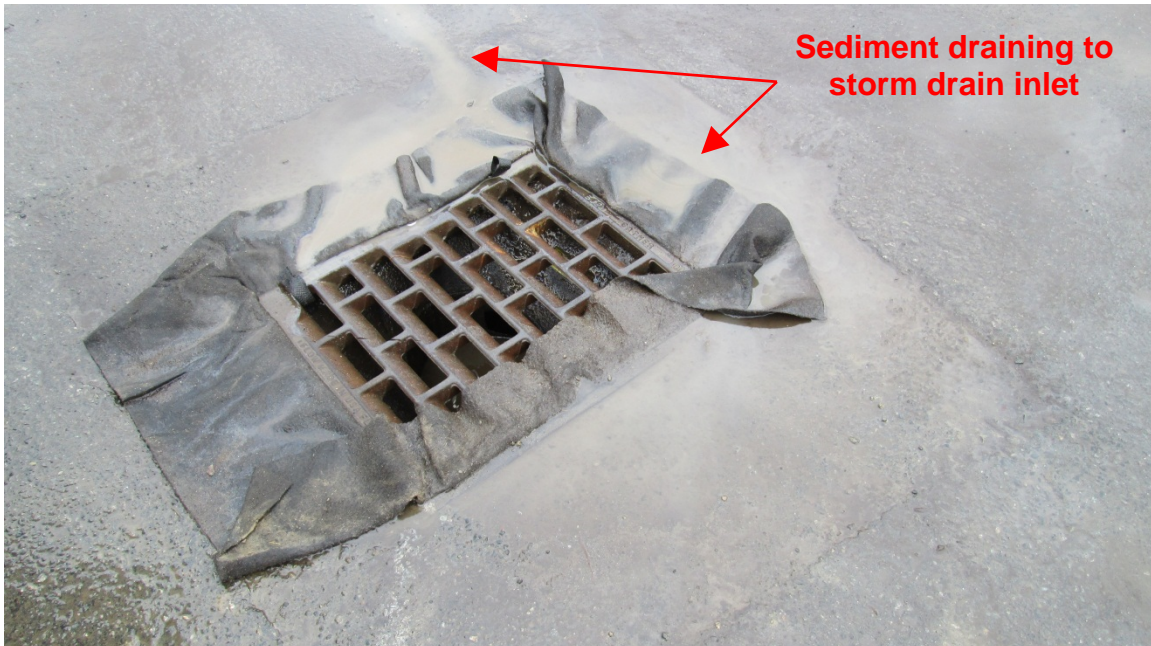
**Photograph 4.** Cathcart Way Operations Center – View of sediment transported to storm drain inlet equipped with inlet protection BMP in the central area of the materials storage yard.

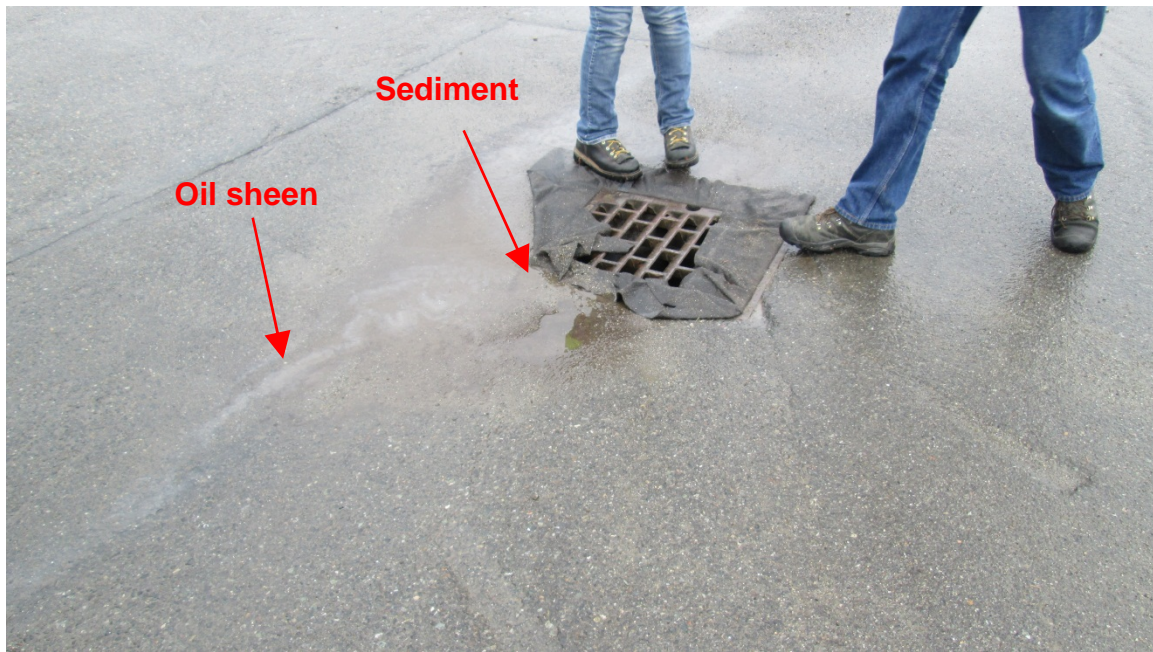
**Photograph 5.** Cathcart Way Operations Center – View of of oil sheen and sediment transported to storm drain inlet equipped with inlet protection BMP in the central area of the materials storage yard.

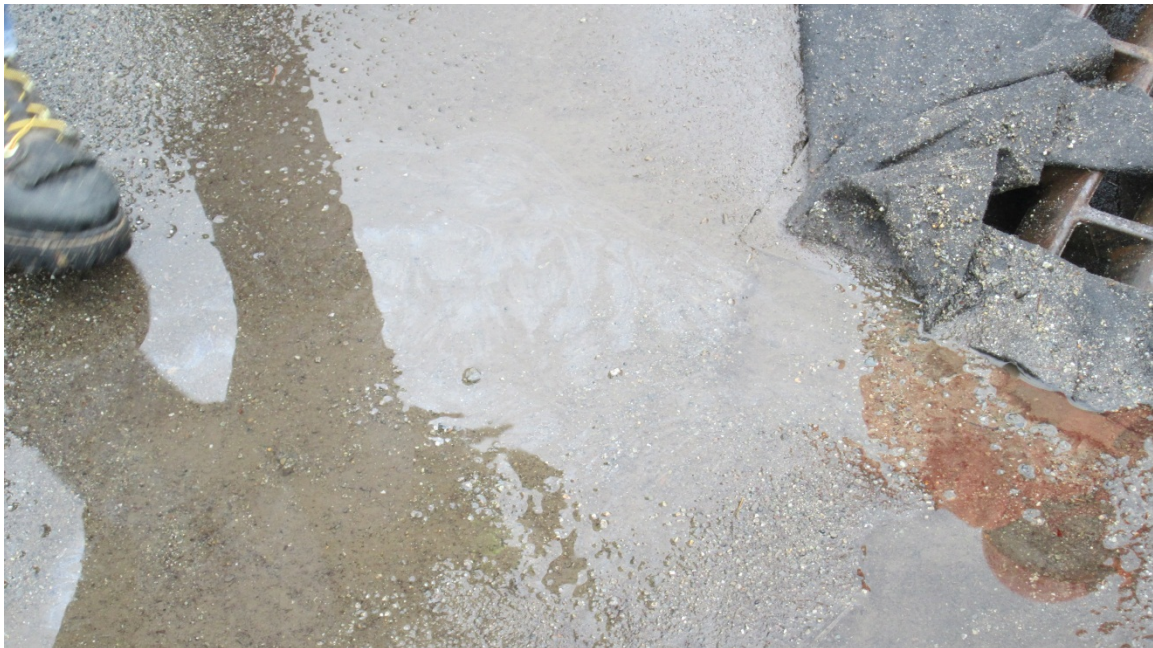
**Photograph 6.** Cathcart Way Operations Center – Close-up view of oil sheen and sediment shown in Photograph 5.

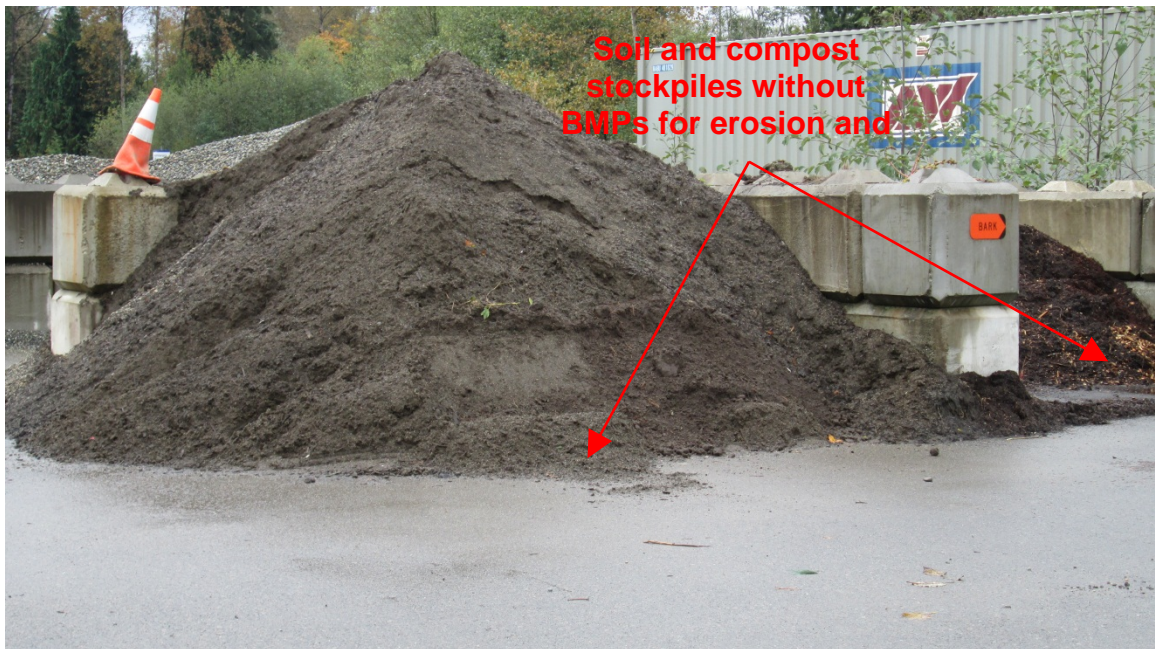
**Photograph 7.** Cathcart Way Operations Center – View of soil and compost stockpiles without BMPs for erosion and sediment control at the north end of the materials storage yard.

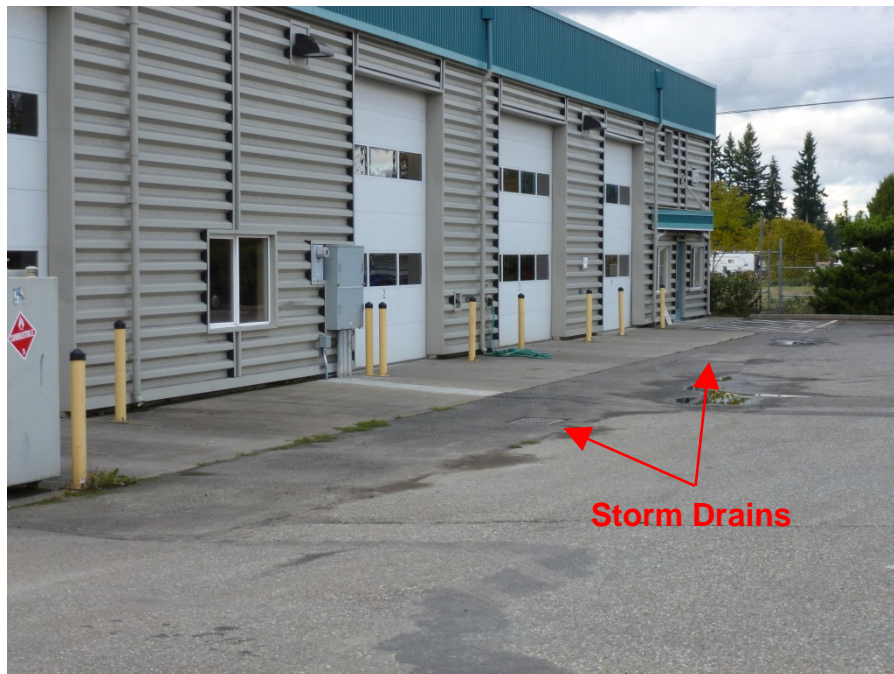
**Photograph 8.** Arlington Operations Center – View of storm drains located on the east side of the Fleet Maintenance building.

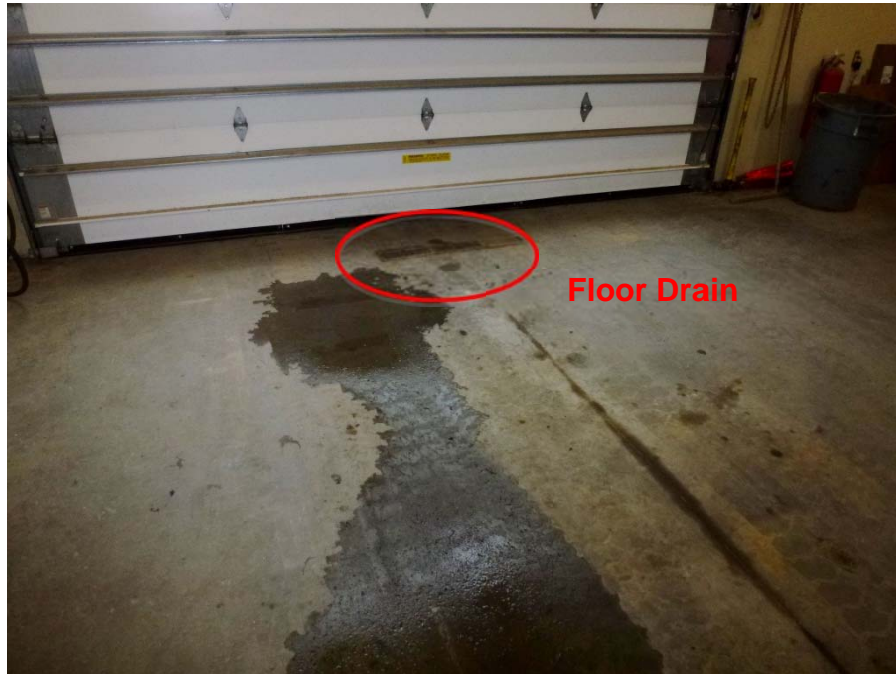
**Photograph 9.** Arlington Operations Center – View of the floor drain located on the west side of the Fleet Maintenance building.

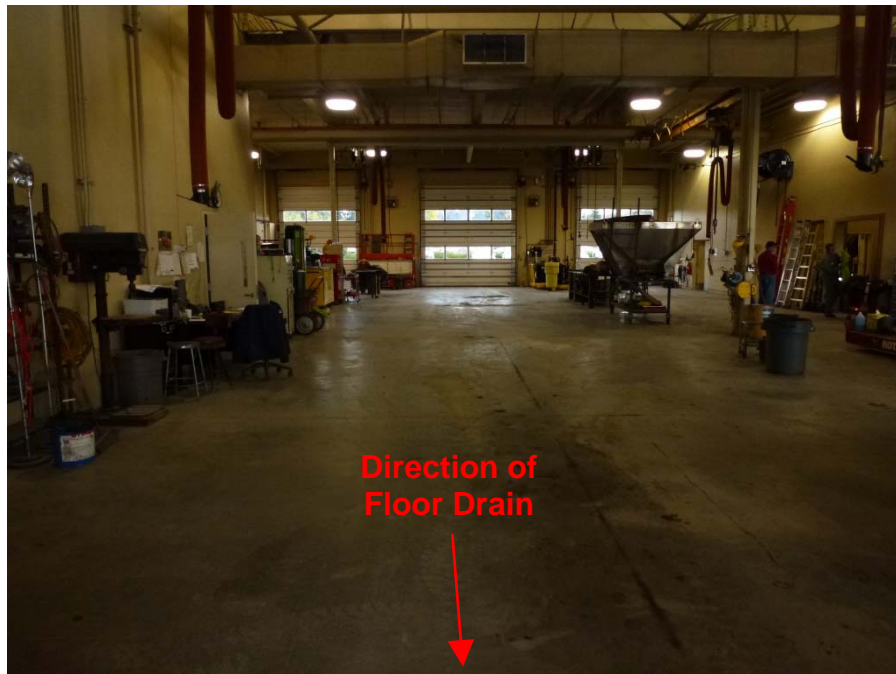
**Photograph 10.** Arlington Operations Center – View of the inside of the Fleet Maintenance building, which drains to the floor drain shown in Photograph 9.

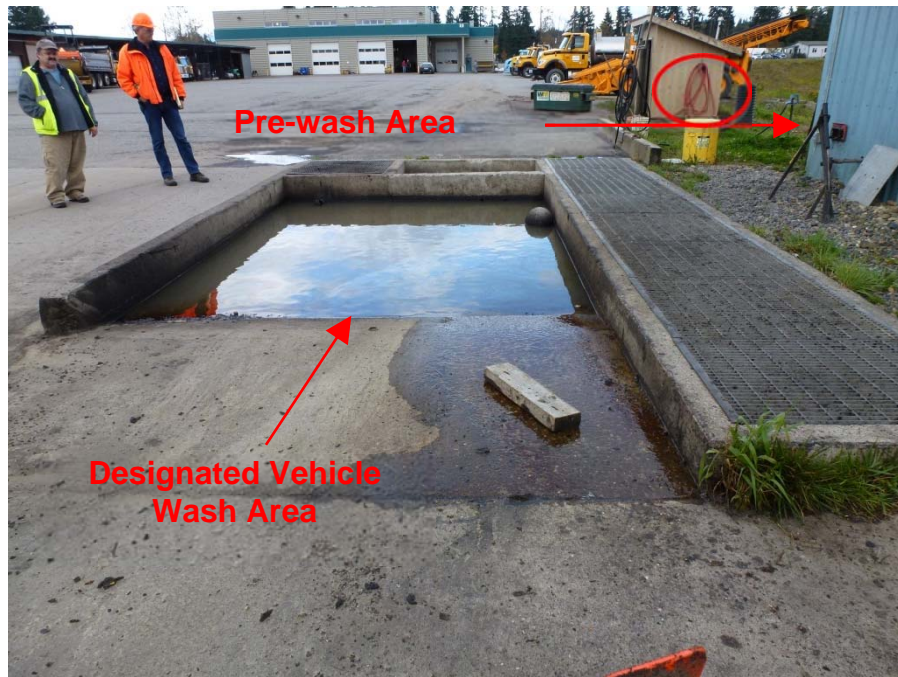
**Photograph 11.** Arlington Operations Center – View of vehicle wash area. Note stationary hose adjacent to the pre-wash area.

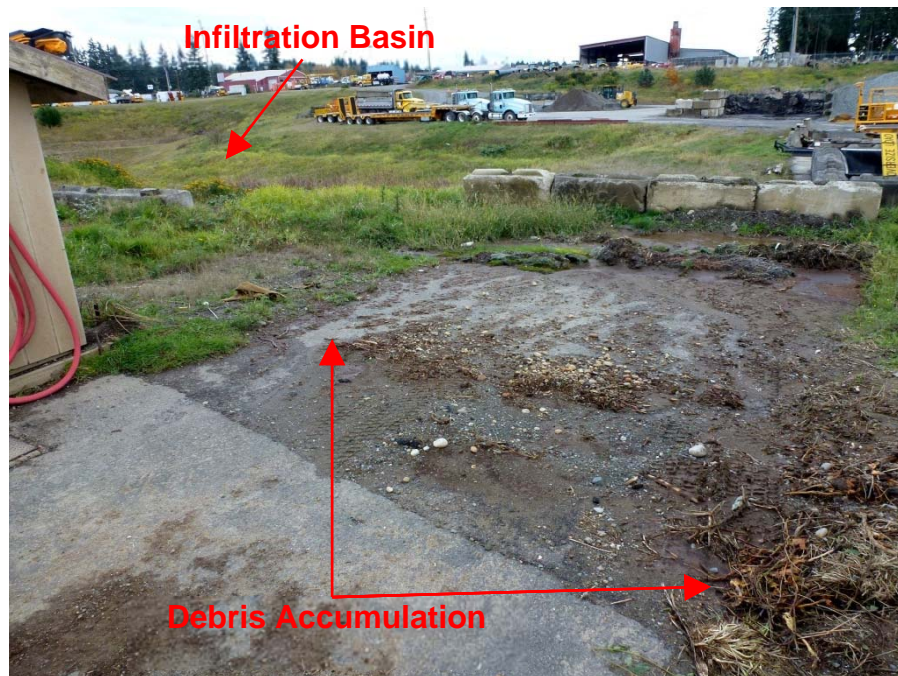
**Photograph 12.** Arlington Operations Center – View of vehicle pre-wash area, adjacent to the infiltration basin. Note the debris accumulation.

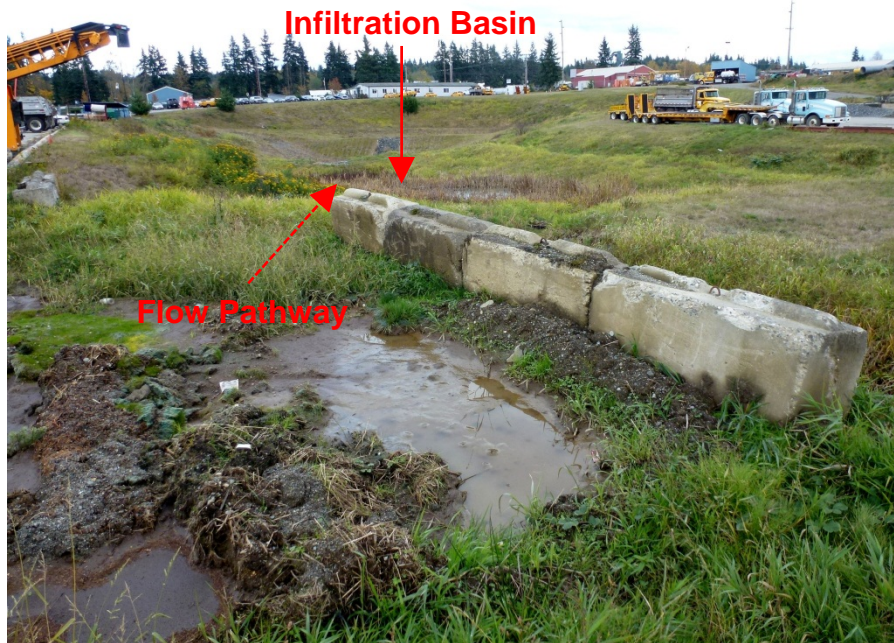
**Photograph 13.** Arlington Operations Center – Additional view of debris accumulation at vehicle pre-wash area. Flow and debris was observed from the area to an earthen ditch that connects to the infiltration basin.

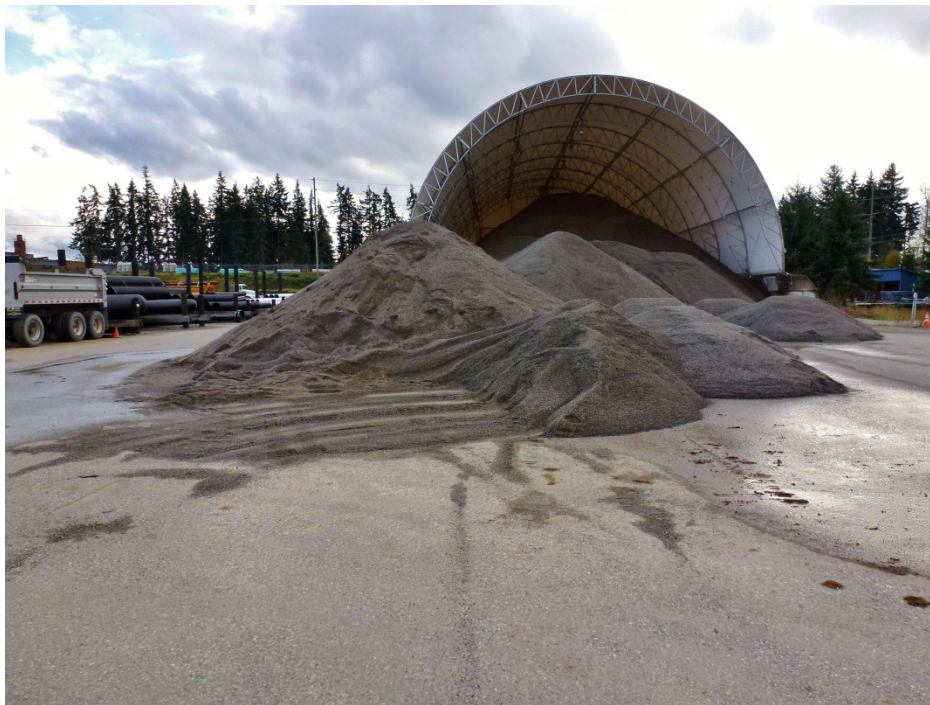
**Photograph 14.** Arlington Operations Center – View of sand storage pile outside of the covered structure and stored on an impervious surface.

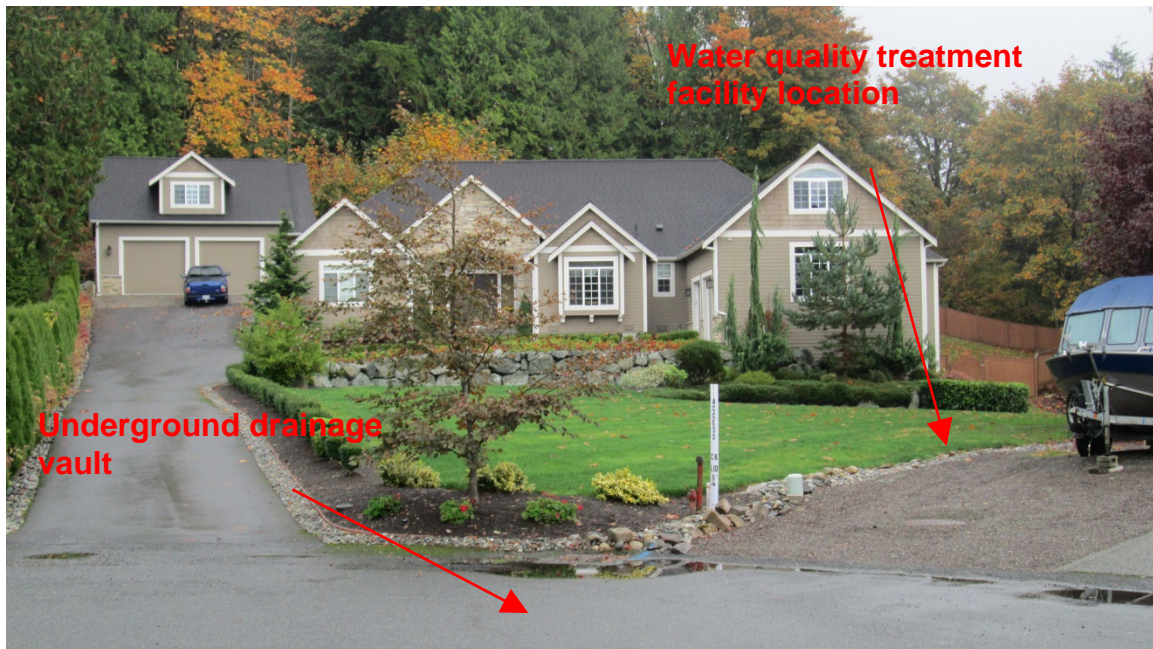
**Photograph 15.** 150<sup>th</sup> Street water quality treatment facility – View of property where water quality treatment facility was removed. Note the location of the re-implemented water quality treatment facility.

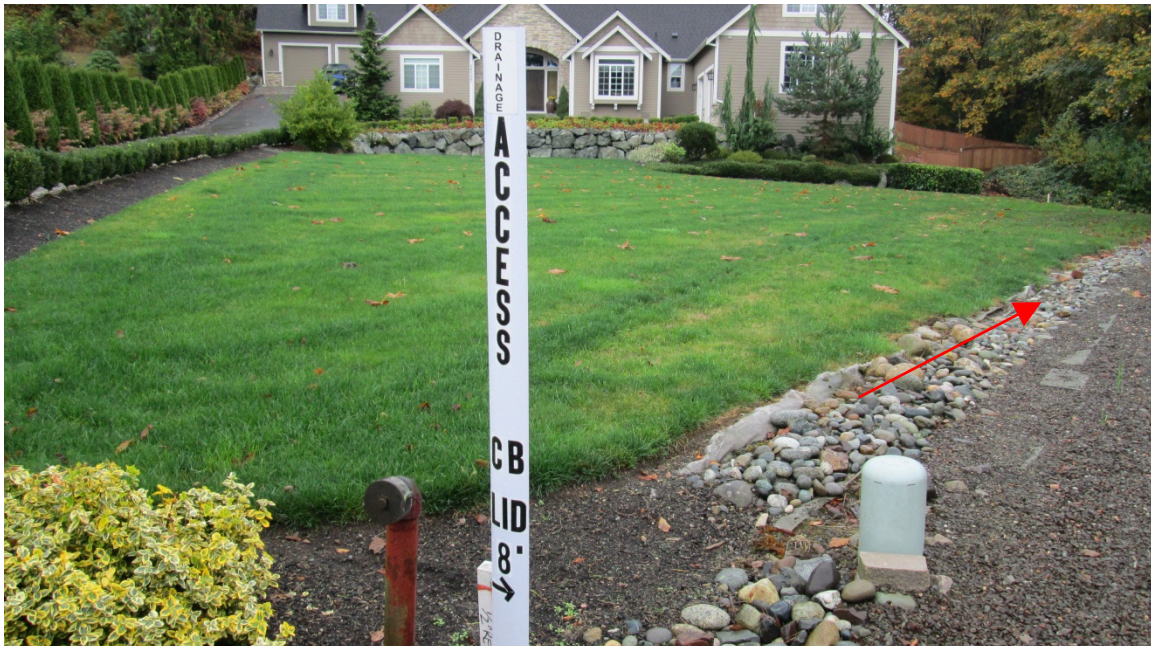
**Photograph 16.** 150<sup>th</sup> Street water quality treatment facility – Closer view of water quality treatment facility shown in Photograph 22.

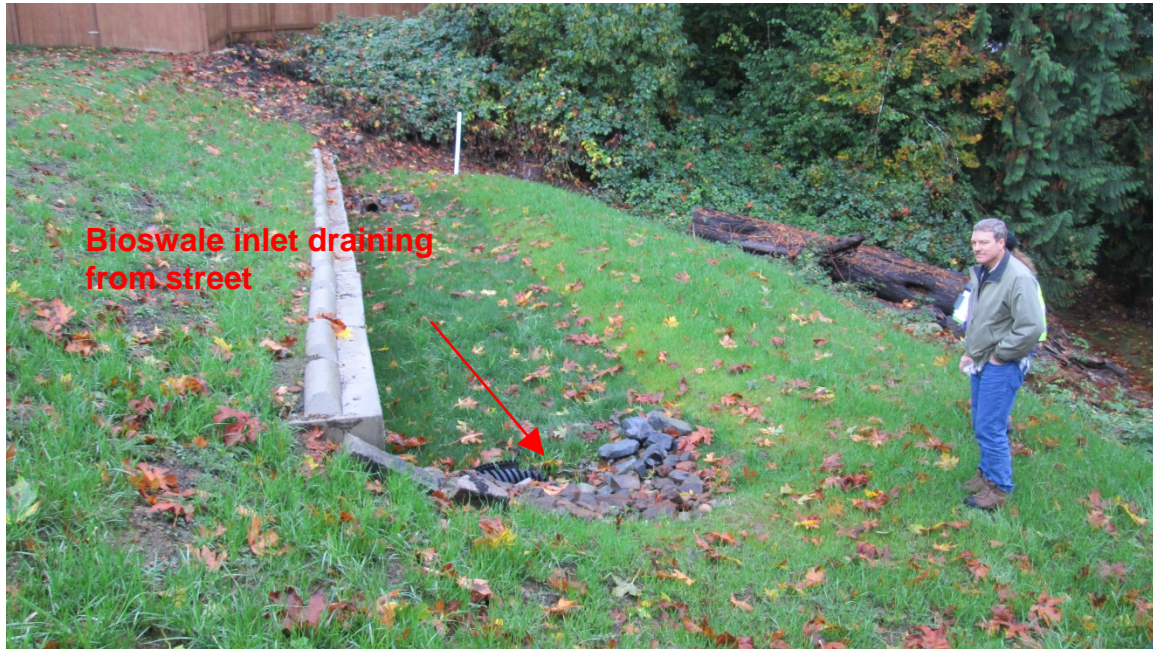
**Photograph 17.** 150<sup>th</sup> Street water quality treatment facility – View of upper tier bioswale maintained as part of the restored bioswale, and receiving drainage from the up-gradient underground vault.

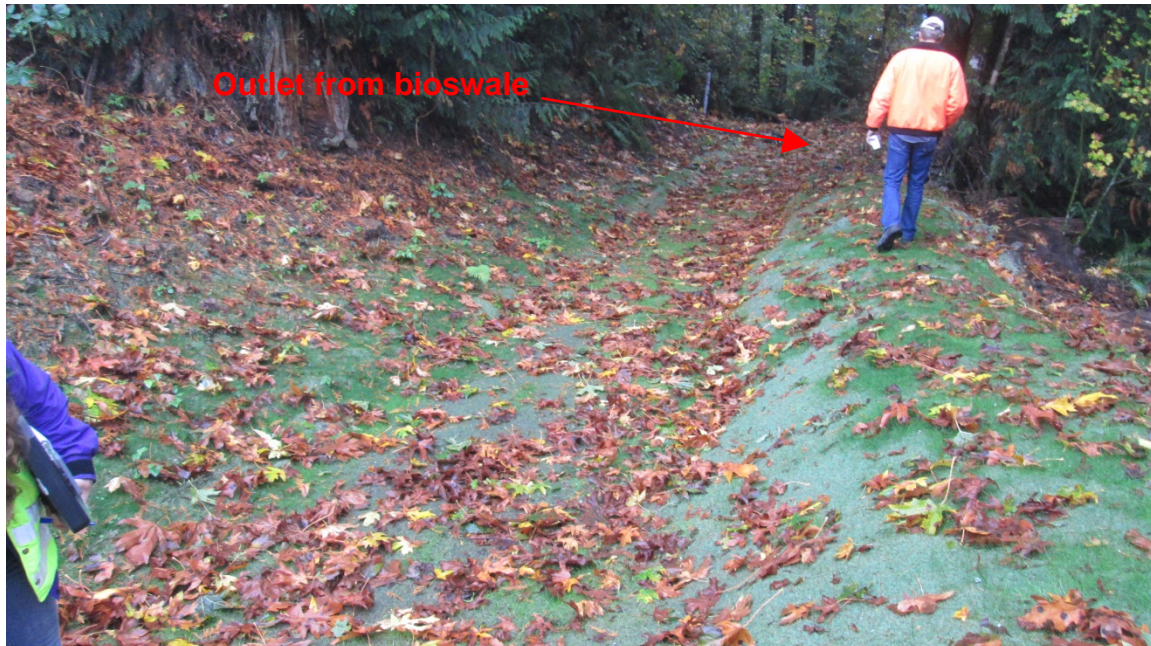
**Photograph 18.** 150<sup>th</sup> Street water quality treatment facility – View of lower tier bioswale maintained as part of the reconstruction of the bioswale and receiving drainage from the residential development.

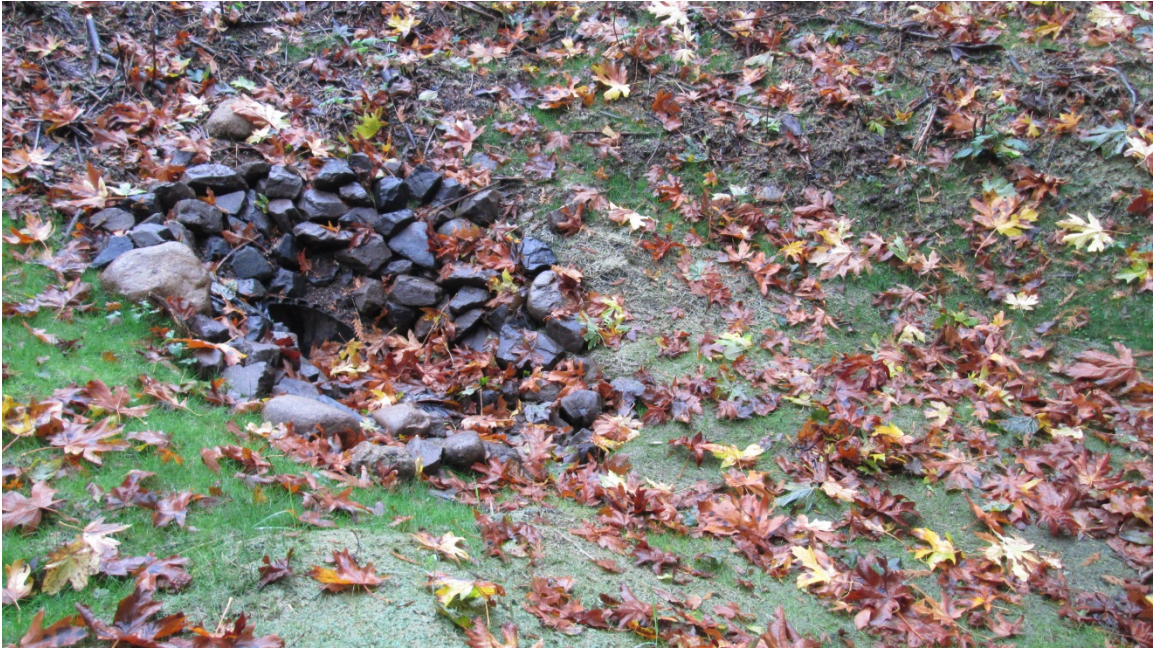
**Photograph 19.**            **150<sup>th</sup> Street water quality treatment facility – View of outlet draining into the County's MS4 from lower tier bioswale.**

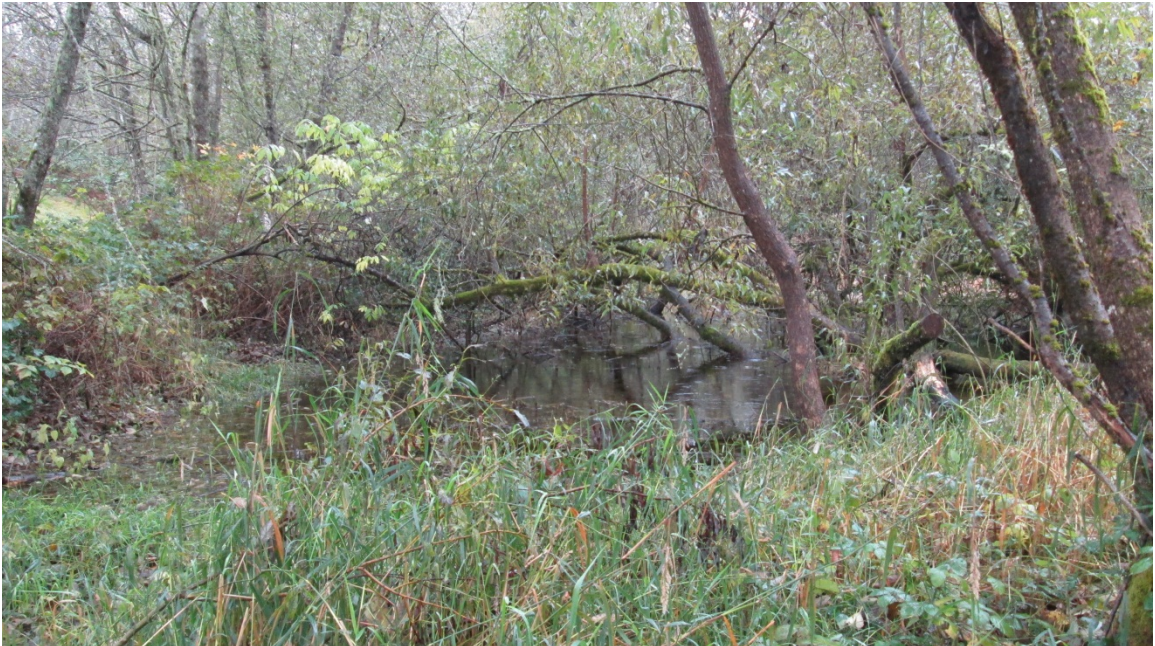
**Photograph 20.**            **121<sup>st</sup> Street water quality treatment facility – View of stormwater pond.**

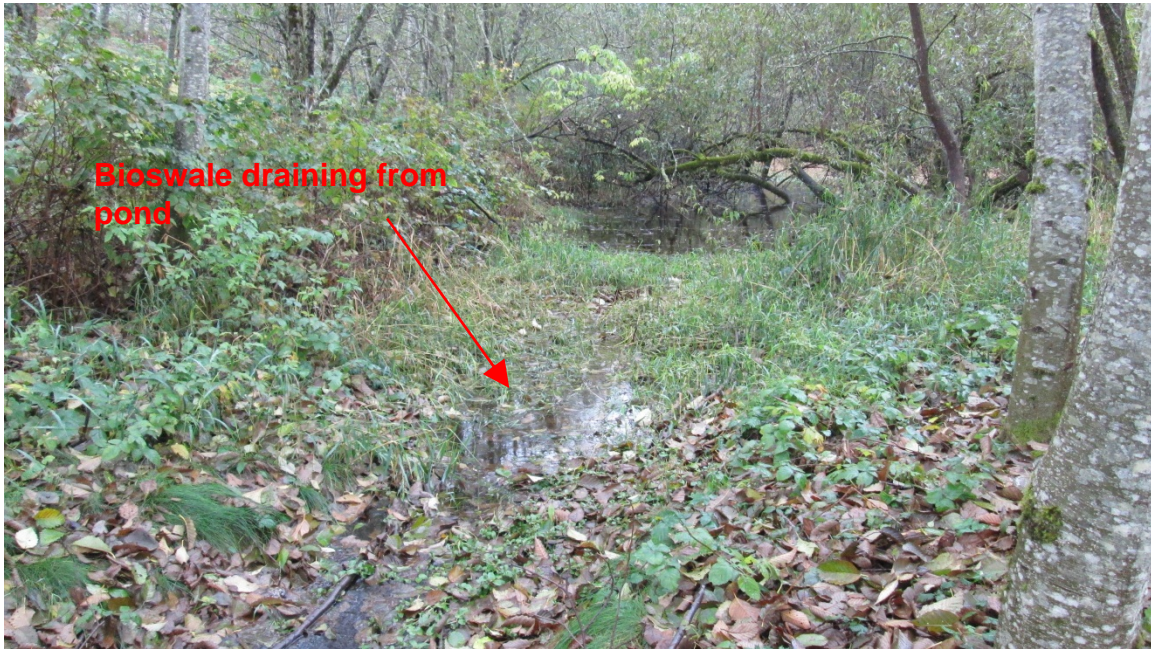
**Photograph 21.** 121<sup>st</sup> Street water quality treatment facility – View of stormwater pond draining to bioswale.

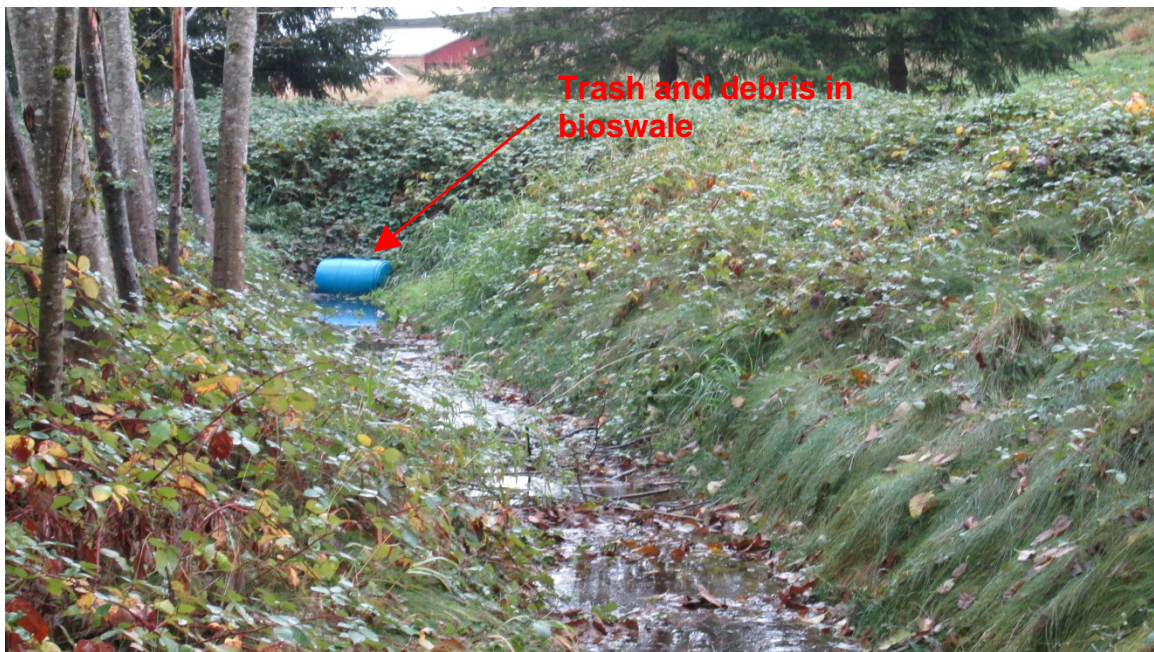
**Photograph 22.** 121<sup>st</sup> Street water quality treatment facility – View of bioswale connected to stormwater pond. Note debris and trash including half of a 55-gallon drum at the down-gradient end of the bioswale.

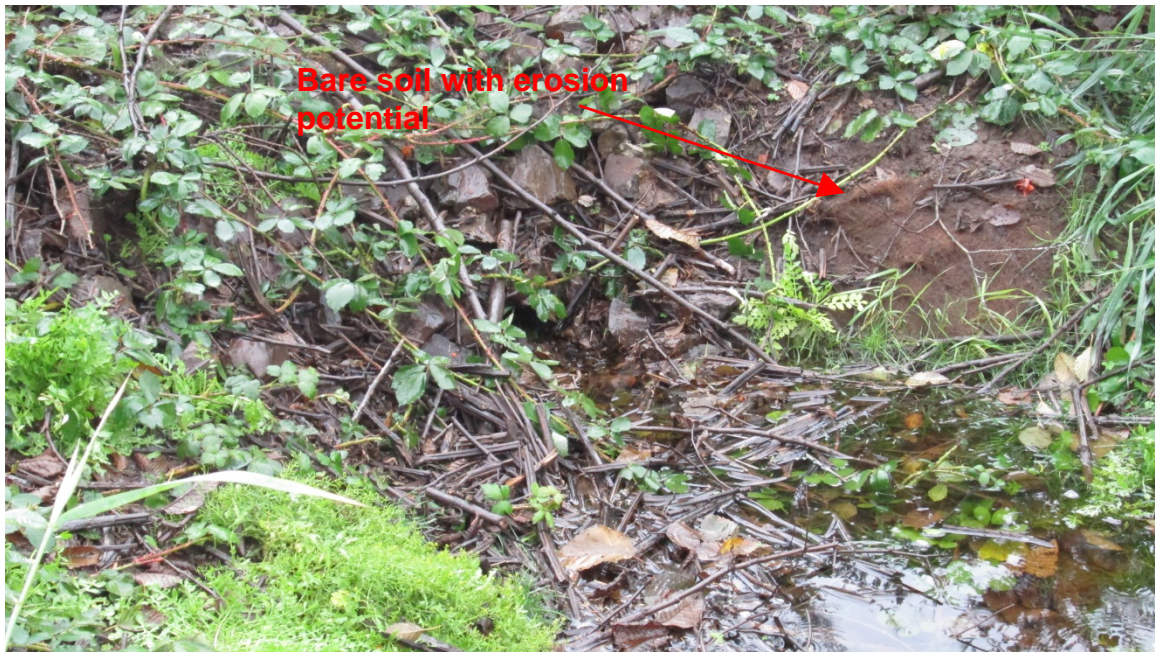
**Photograph 23. 121<sup>st</sup> Street water quality treatment facility – Closeup view of bioswale wall. Note the lack of vegetation and potential for erosion.**
